MINUTES OF THE AMENITIES COMMITTEE MEETING HELD ON  
MONDAY 2nd MARCH 2026 AT THE TOWN HALL

Inspected: 14-January-2026 - 10:58 by Liam Last (RPII Annual Inspector)

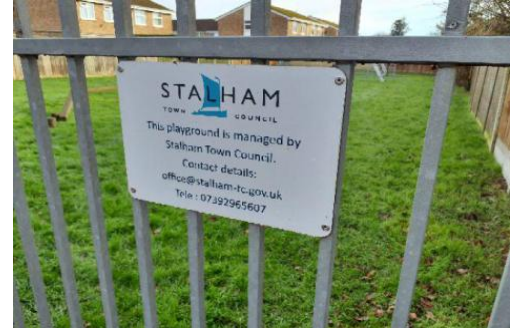
**Item:** Sign  
**Manufacturer:** Not Identified  
**Surface Type:** N/A  
**Item Quantity:** 1  
**Equipment Compliance:** N/A  
**Surface Area Compliance:** N/A

BS EN 1176 Part 7 recommends that signage shall include the site name / address - Provide additional information

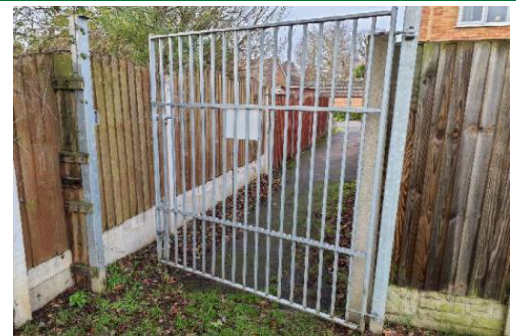
**Item:** Gate  
**Manufacturer:** Not Identified  
**Surface Type:** Grass  
**Item Quantity:** 2  
**Equipment Compliance:** N/A  
**Surface Area Compliance:** N/A

There are openings that are less than 12mm that could trap or crush fingers - Provide a 12mm gap throughout full range of motion at both sides of gate

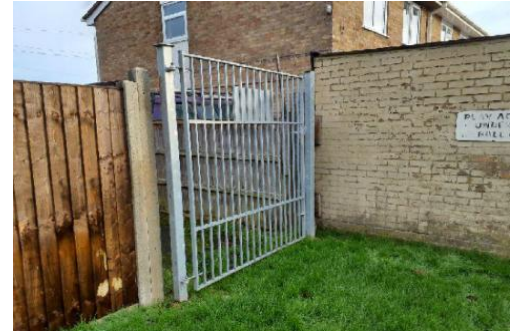
**Item:** Gate  
**Manufacturer:** Not Identified  
**Surface Type:** Grass  
**Item Quantity:** 1  
**Equipment Compliance:** N/A  
**Surface Area Compliance:** N/A

The gate/s was / were locked or secured at the time of the inspection and a full inspection could not be undertaken - Complete inspection of gate/s when re-opened

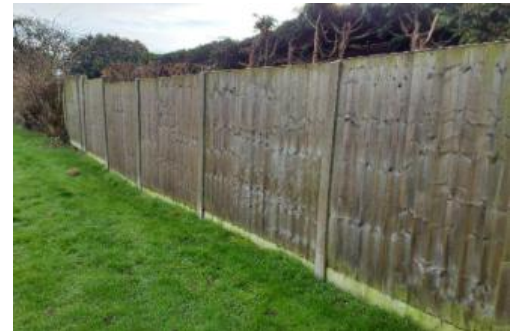
**Item:** Fencing - Timber  
**Manufacturer:** Not Identified  
**Surface Type:** Grass  
**Item Quantity:** 1  
**Equipment Compliance:** N/A  
**Surface Area Compliance:** N/A

This item is satisfactory - no work required -

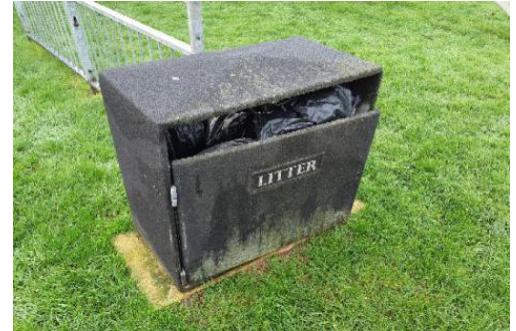
**Item:** Litter Bin  
**Manufacturer:** Not Identified  
**Surface Type:** Grass  
**Item Quantity:** 1  
**Equipment Compliance:** N/A  
**Surface Area Compliance:** N/A

The lid or door of the litter bin is not secured - Ensure the lid or door is kept locked

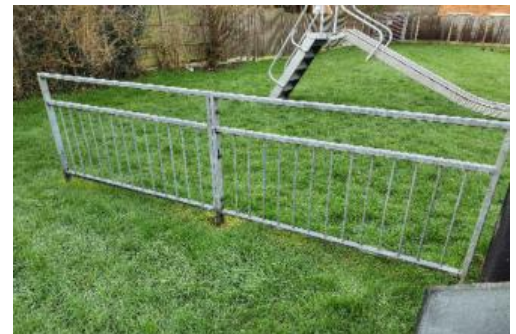
**Item:** Swing Barrier  
**Manufacturer:** Not Identified  
**Surface Type:** Grass  
**Item Quantity:** 1  
**Equipment Compliance:** N/A  
**Surface Area Compliance:** N/A

This item is satisfactory - no work required -

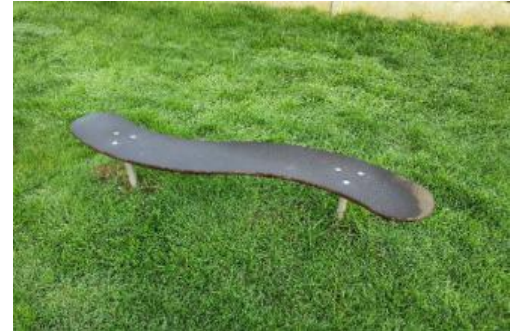
**Item:** Balance Beam  
**Manufacturer:** Playdale Playgrounds Ltd  
**Surface Type:** Grass  
**Item Quantity:** 1  
**Equipment Compliance:** Yes  
**Surface Area Compliance:** Yes

This item is satisfactory - no work required -

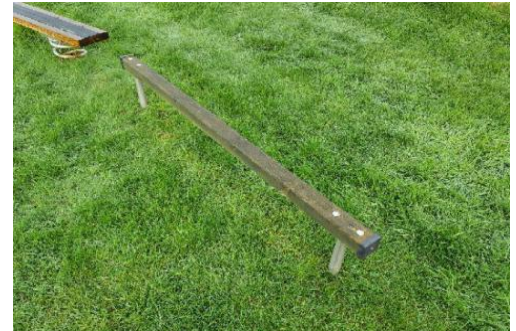
**Item:** Balance Beam  
**Manufacturer:** Playdale Playgrounds Ltd  
**Surface Type:** Grass  
**Item Quantity:** 1  
**Equipment Compliance:** Yes  
**Surface Area Compliance:** Yes

There is algae or moss on the surface of the equipment - Clean and treat appropriately

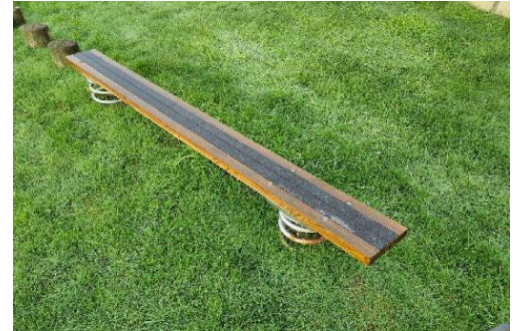
**Item:** Wobble Board  
**Manufacturer:** Playdale Playgrounds Ltd  
**Surface Type:** Grass  
**Item Quantity:** 1  
**Equipment Compliance:** Yes  
**Surface Area Compliance:** Yes

The paintwork on the spring has been damaged or worn exposing the metal underneath which is rusting - Treat any rusting components and repaint

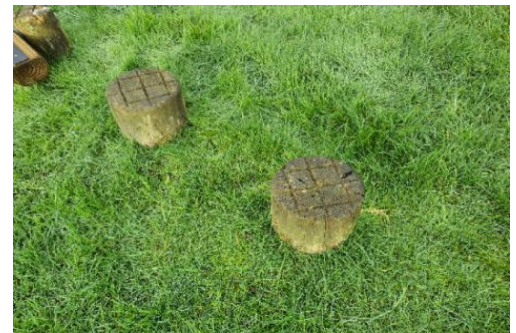
**Item:** Stepping Stones  
**Manufacturer:** Playdale Playgrounds Ltd  
**Surface Type:** Grass  
**Item Quantity:** 4  
**Equipment Compliance:** Yes  
**Surface Area Compliance:** Yes

There is some evidence of rot in the timber - Monitor for any further deterioration and replace as required

There is some strimmer / machinery damage apparent on the posts, this can penetrate the preservative applied to the timber and accelerate the rotting process - Monitor for any deterioration (rot) and replace as required

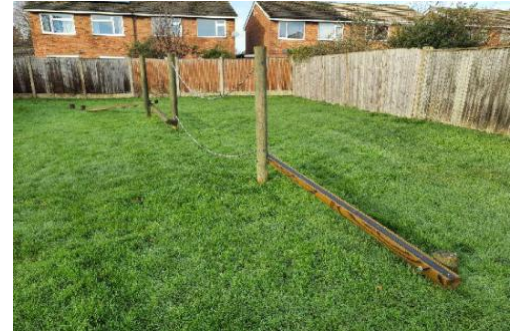
**Item:** Activity Trail  
**Manufacturer:** Playdale Playgrounds Ltd  
**Surface Type:** Grass  
**Item Quantity:** 1  
**Equipment Compliance:** Yes  
**Surface Area Compliance:** Yes

There is some strimmer / machinery damage apparent on the posts, this can penetrate the preservative applied to the timber and accelerate the rotting process - Monitor for any deterioration (rot) and replace as required

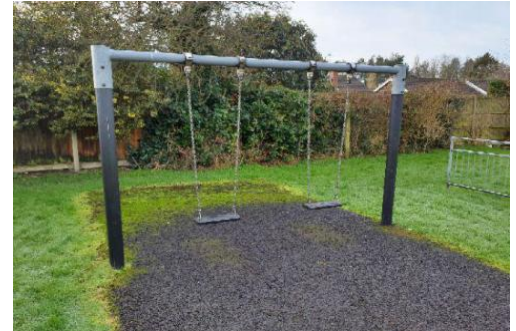
**Item:** 1 Bay 2 Seat (Flat)  
**Manufacturer:** Playdale Playgrounds Ltd  
**Surface Type:** Bonded Rubber Mulch  
**Item Quantity:** 1  
**Equipment Compliance:** Yes  
**Surface Area Compliance:** Yes

**Total Findings:** 4

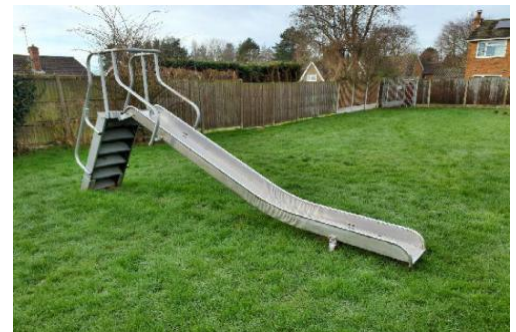
**Item:** Free Standing Slide  
**Manufacturer:** Not Identified  
**Surface Type:** Grass Matrix Tiles  
**Item Quantity:** 1  
**Equipment Compliance:** No  
**Surface Area Compliance:** Yes

**Total Findings:** 6

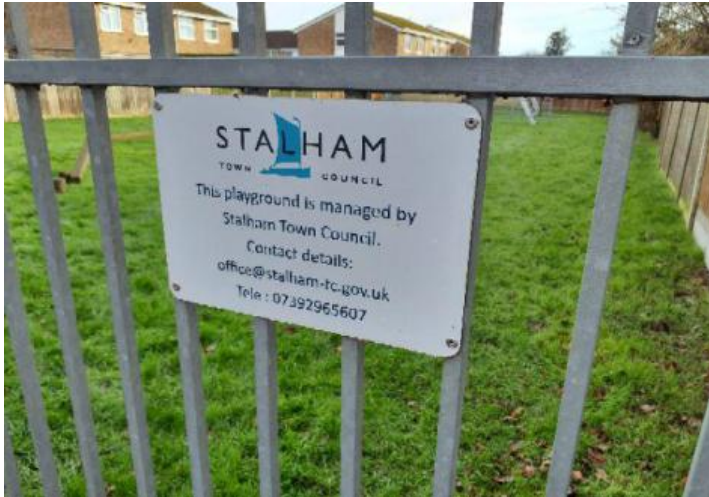
**Item:** Ancillary Items - Sign  
**Manufacturer:** Not Identified

**Finding:** BS EN 1176 Part 7 recommends that signage shall include the site name / address  
**Action:** Provide additional information

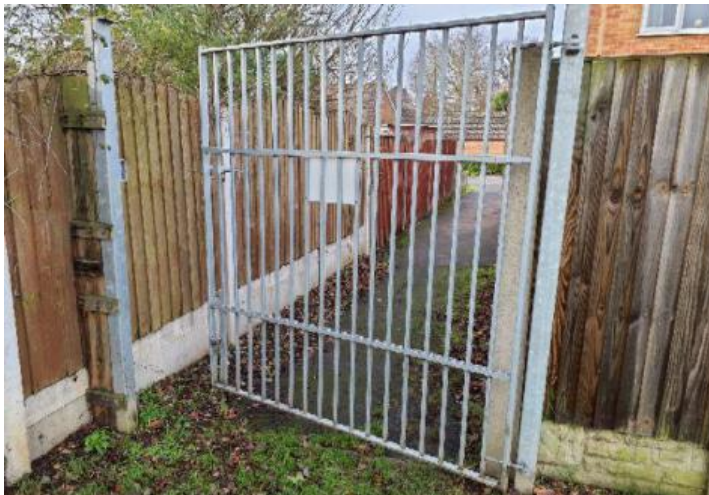
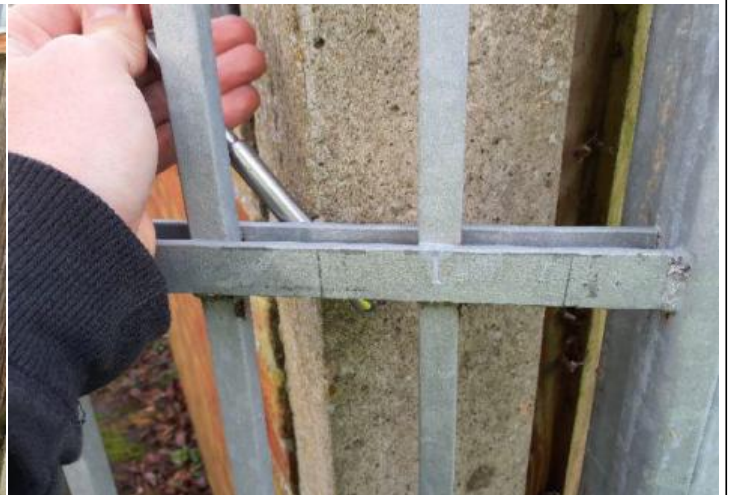
**Item:** Gates - Gate  
**Manufacturer:** Not Identified

**Finding:** There are openings that are less than 12mm that could trap or crush fingers

**Action:** Provide a 12mm gap throughout full range of motion at both sides of gate

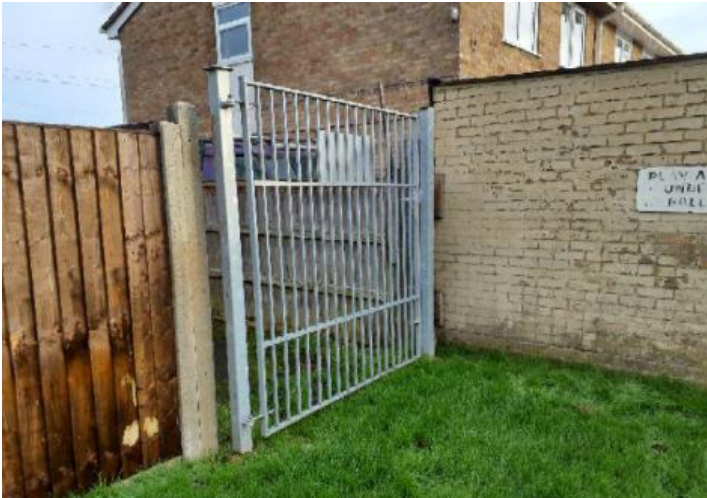
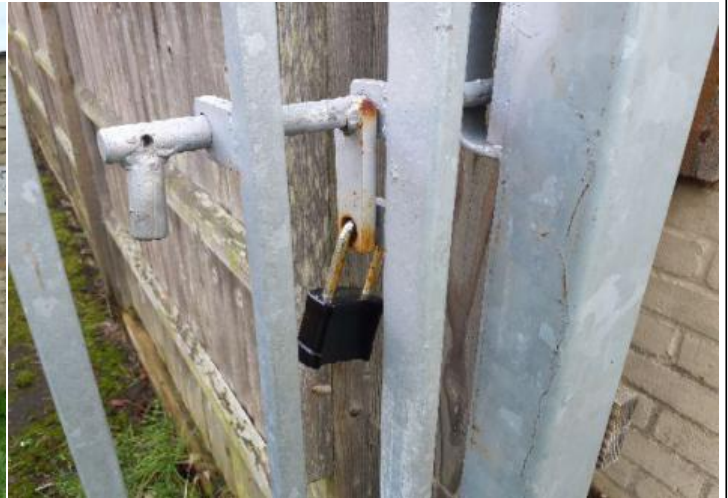
**Item:** Gates - Gate  
**Manufacturer:** Not Identified

**Finding:** The gate/s was / were locked or secured at the time of the inspection and a full inspection could not be undertaken

**Action:** Complete inspection of gate/s when re-opened

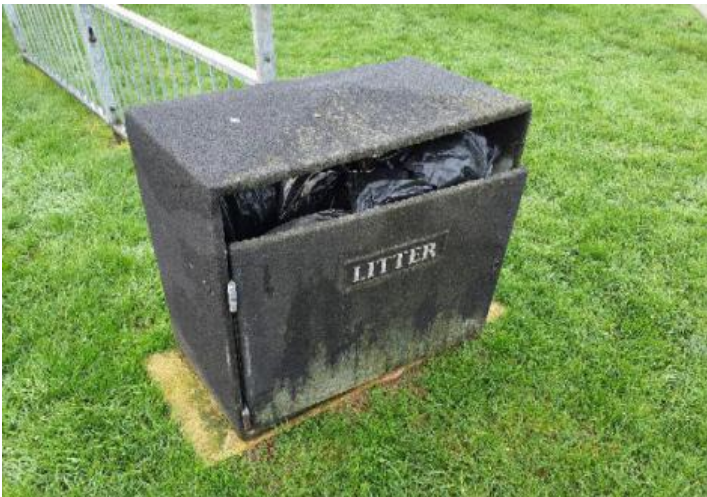
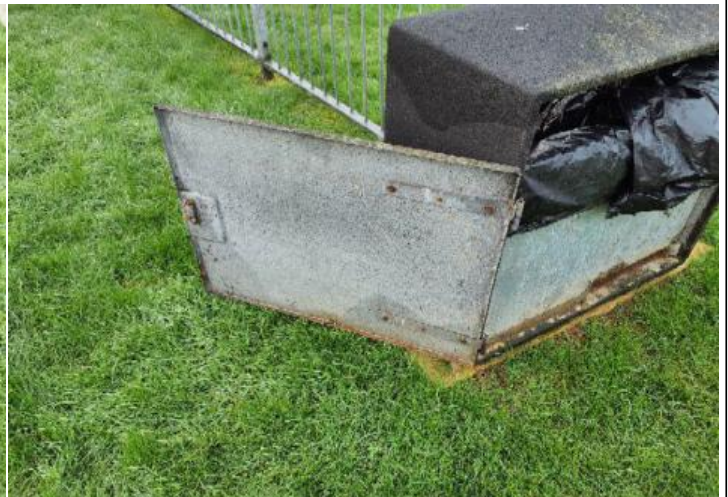
**Item:** Ancillary Items - Litter Bin  
**Manufacturer:** Not Identified

**Finding:** The lid or door of the litter bin is not secured

**Action:** Ensure the lid or door is kept locked

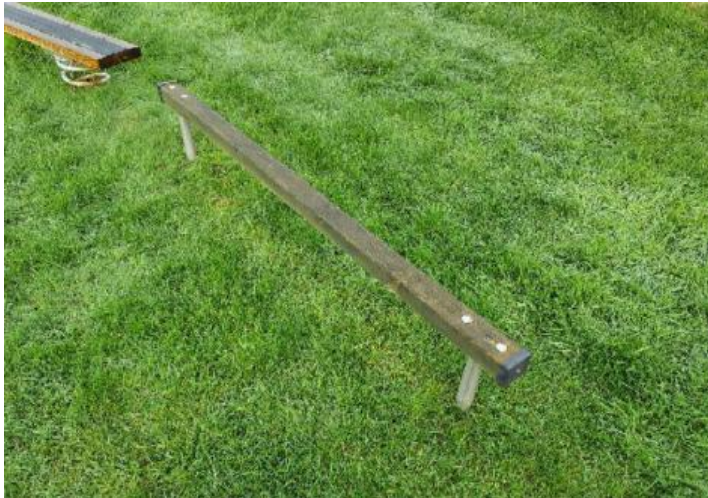
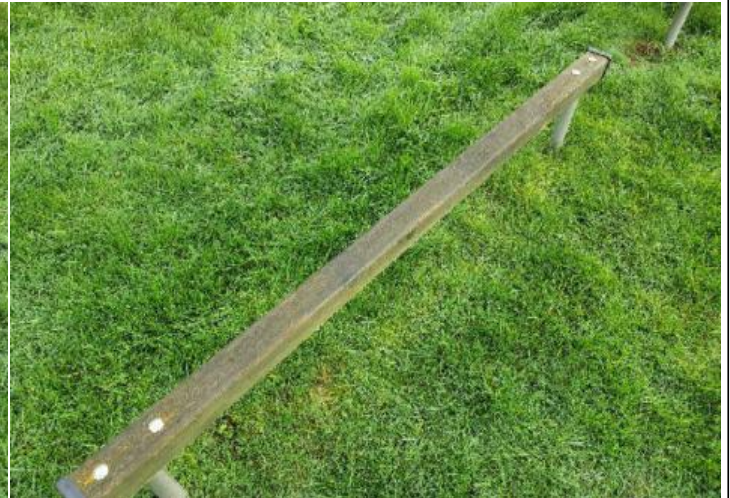
**Item:** Activity Equipment - Balance Beam  
**Manufacturer:** Playdale Playgrounds Ltd

**Finding:** There is algae or moss on the surface of the equipment

**Action:** Clean and treat appropriately

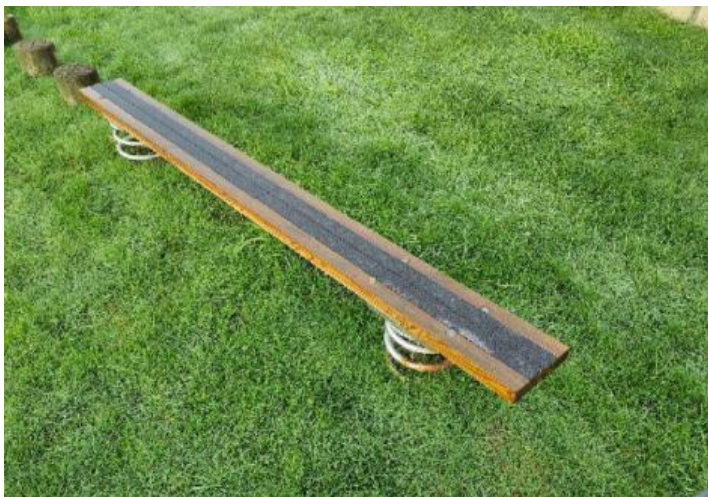
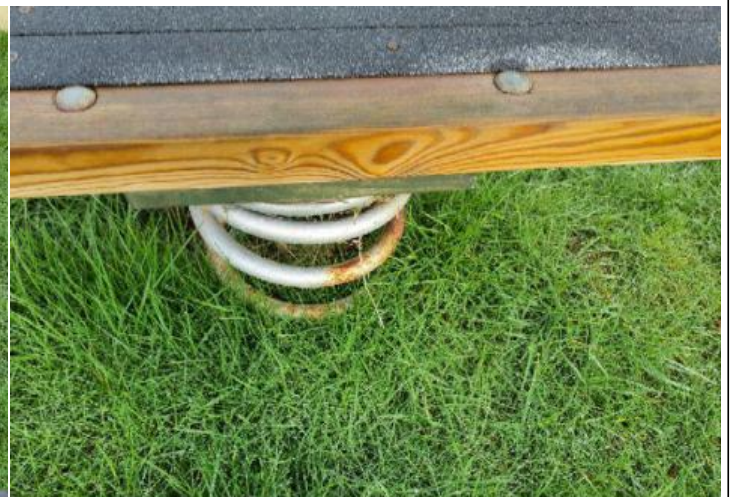
**Item:** Rocking Equipment - Wobble Board  
**Manufacturer:** Playdale Playgrounds Ltd

**Finding:** The paintwork on the spring has been damaged or worn exposing the metal underneath which is rusting

**Action:** Treat any rusting components and repaint

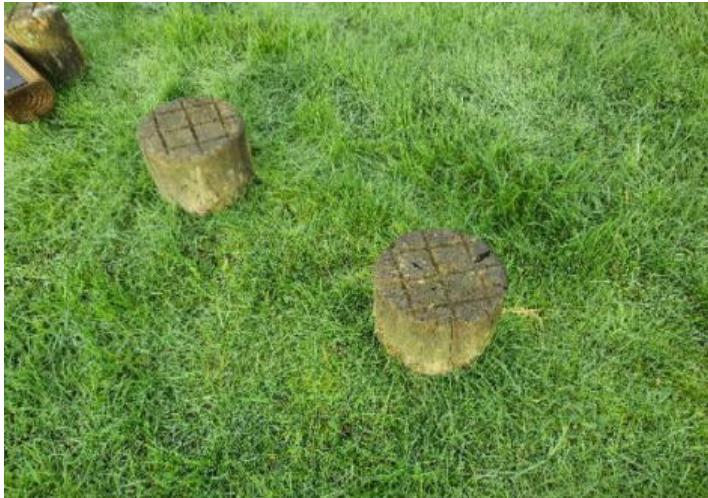
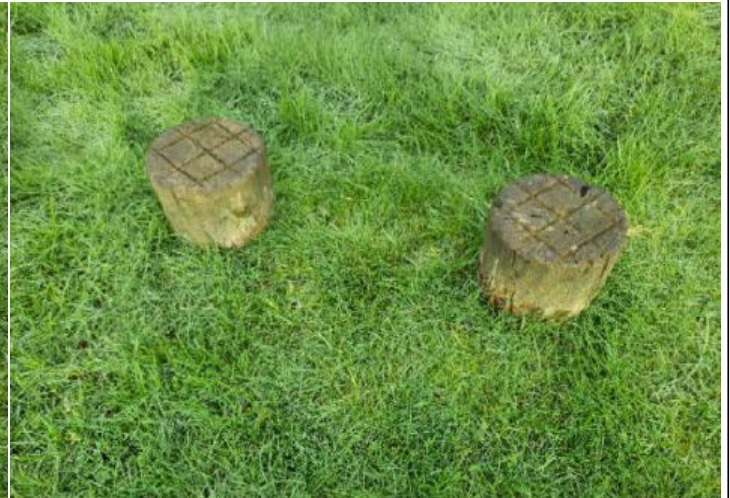
**Item:** Activity Equipment - Stepping Stones  
**Manufacturer:** Playdale Playgrounds Ltd

**Finding:** There is some evidence of rot in the timber

**Action:** Monitor for any further deterioration and replace as required

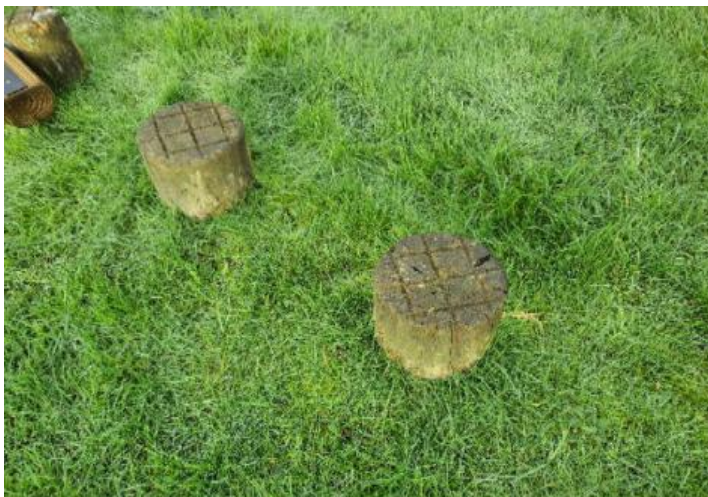
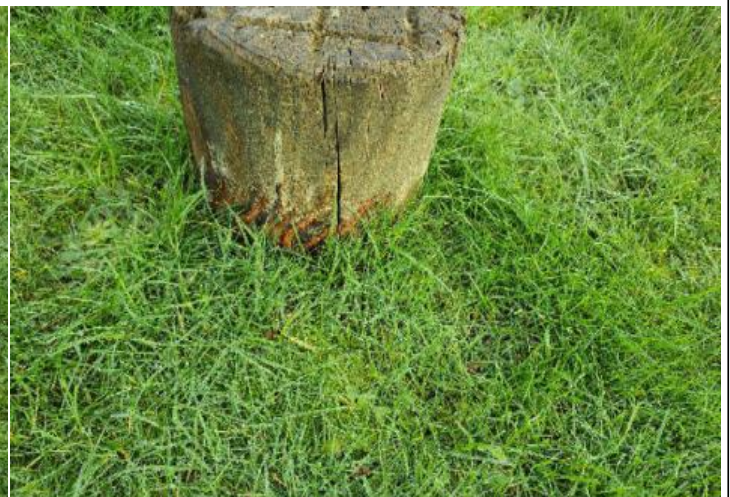
**Item:** Activity Equipment - Stepping Stones  
**Manufacturer:** Playdale Playgrounds Ltd

**Finding:** There is some strimmer / machinery damage apparent on the posts, this can penetrate the preservative applied to the timber and accelerate the rotting process

**Action:** Monitor for any deterioration (rot) and replace as required

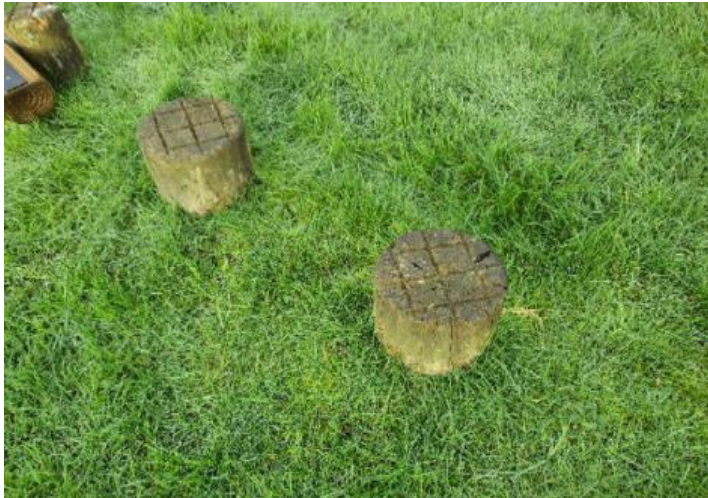
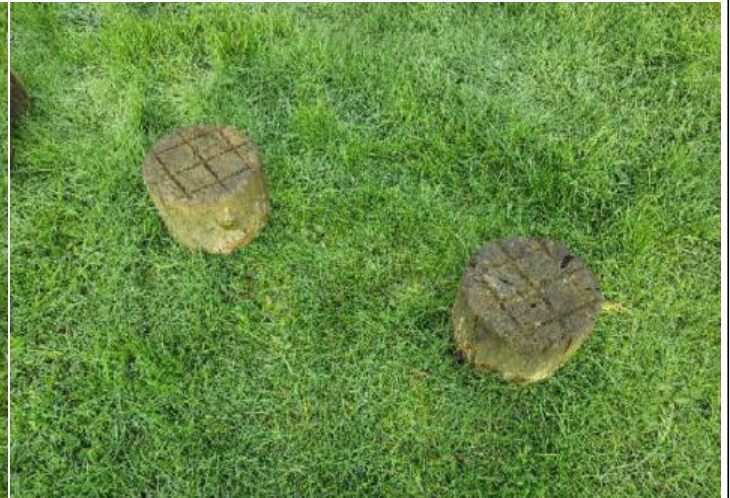
**Item:** Activity Equipment - Stepping Stones  
**Manufacturer:** Playdale Playgrounds Ltd

**Finding:** There is algae or moss on the surface of the equipment

**Action:** Clean and treat appropriately

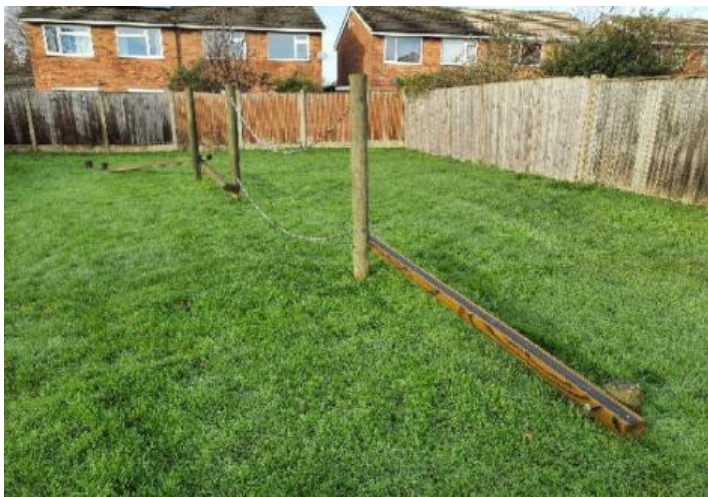
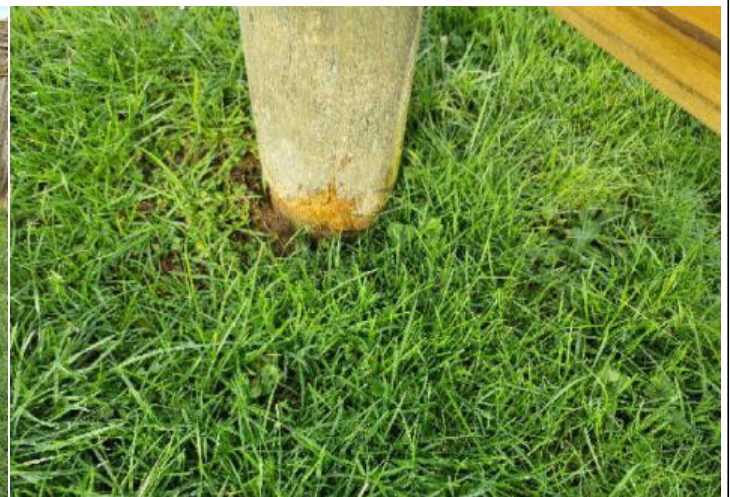
**Item:** Activity Equipment - Activity Trail  
**Manufacturer:** Playdale Playgrounds Ltd

**Finding:** There is some trimmer / machinery damage apparent on the posts, this can penetrate the preservative applied to the timber and accelerate the rotting process

**Action:** Monitor for any deterioration (rot) and replace as required

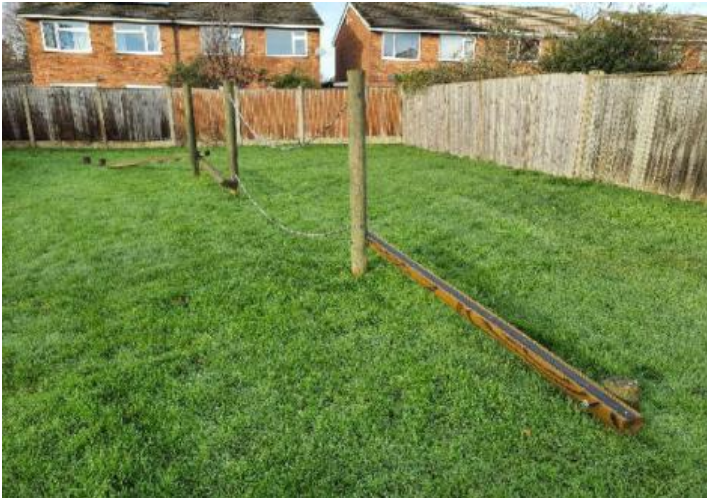
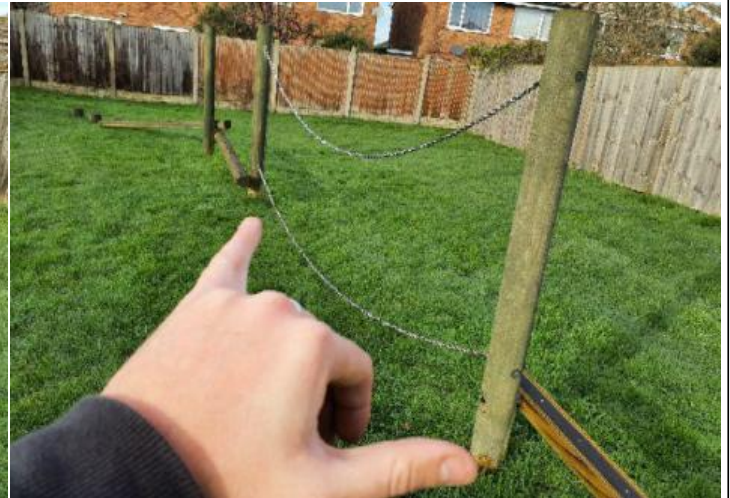
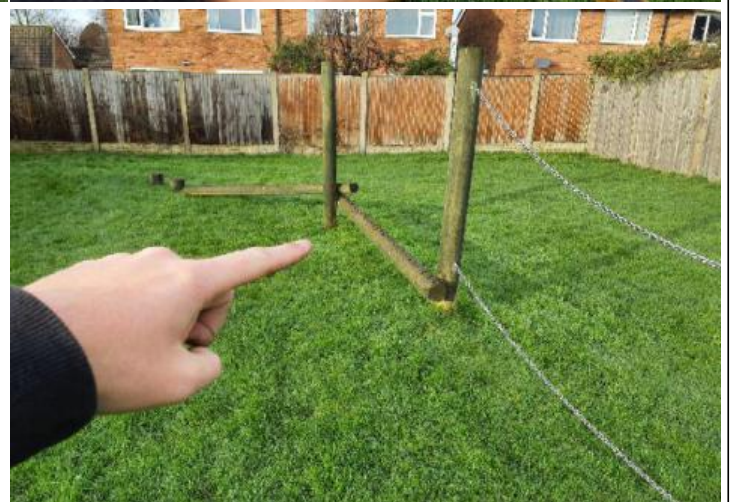
**Item:** Activity Equipment - Activity Trail  
**Manufacturer:** Playdale Playgrounds Ltd

**Finding:** There is some evidence of rot in the timber

**Action:** Monitor for any further deterioration and replace as required

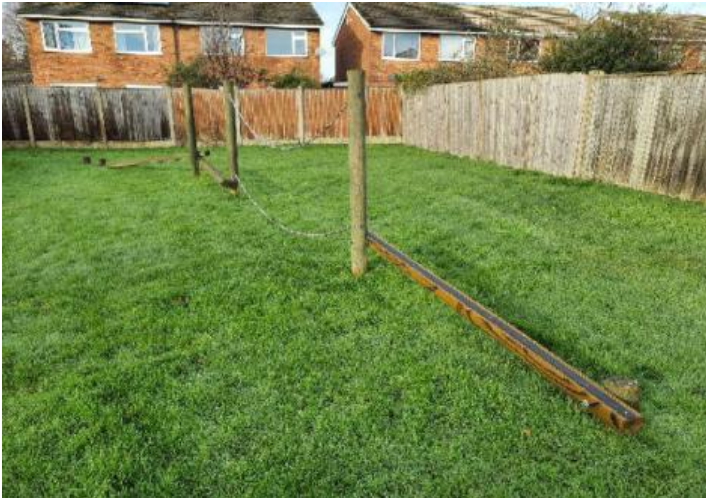
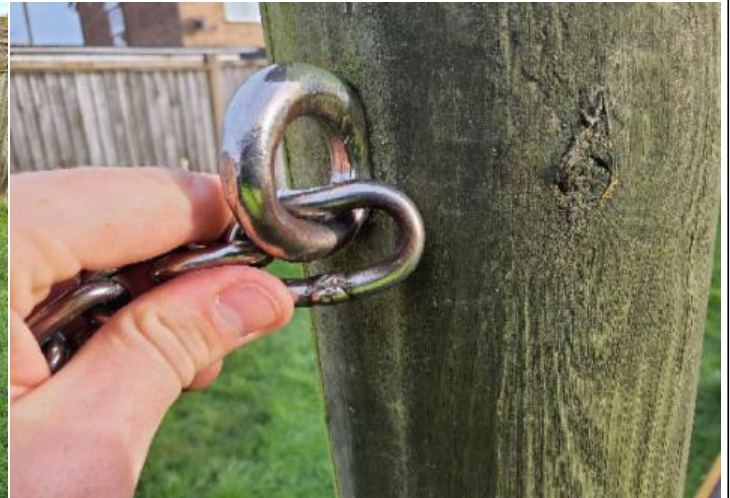
**Item:** Activity Equipment - Activity Trail  
**Manufacturer:** Playdale Playgrounds Ltd

**Finding:** There is some notable evidence of chain wear

**Action:** Monitor for any further deterioration and replace when 40% worn

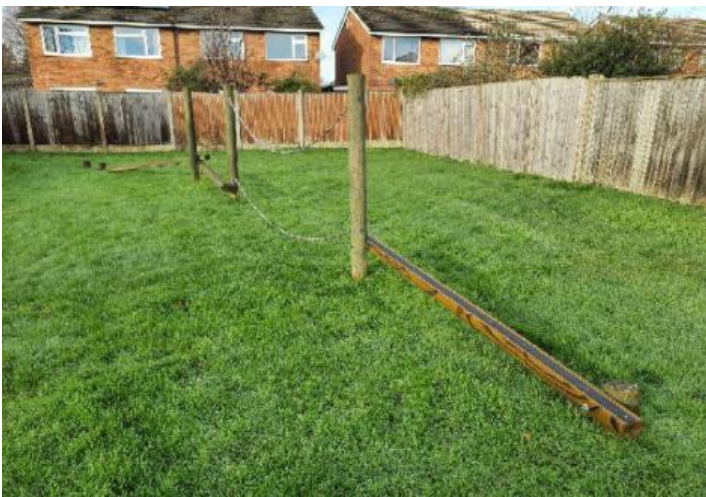
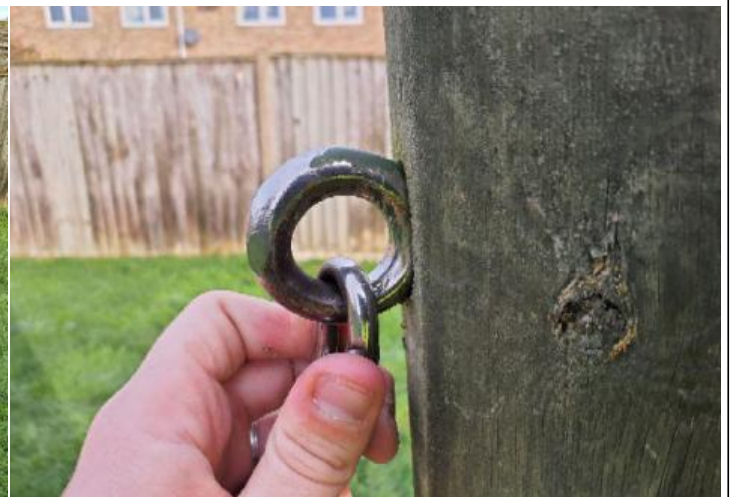
**Item:** Activity Equipment - Activity Trail  
**Manufacturer:** Playdale Playgrounds Ltd

**Finding:** The connecting lugs are showing signs of wear

**Action:** Monitor for any further deterioration and repair as required

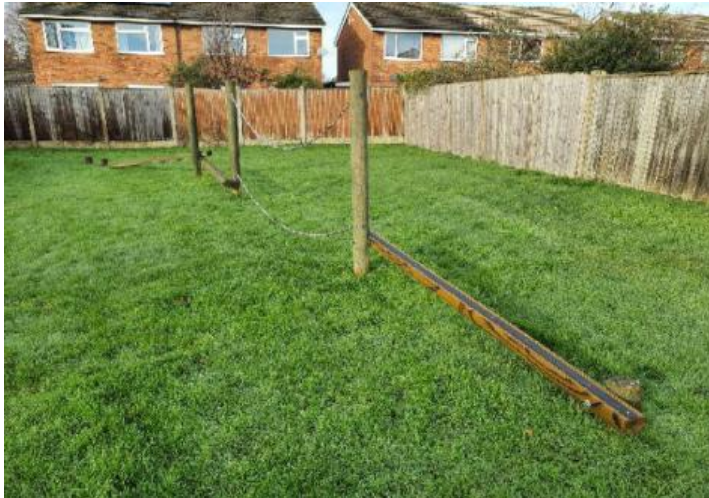
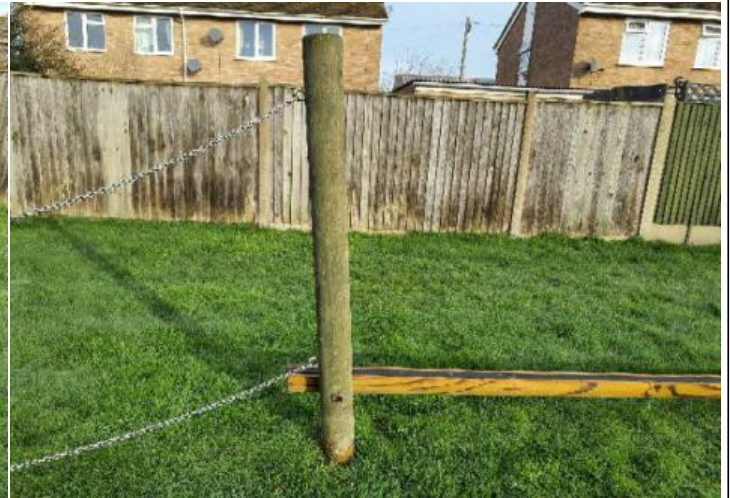
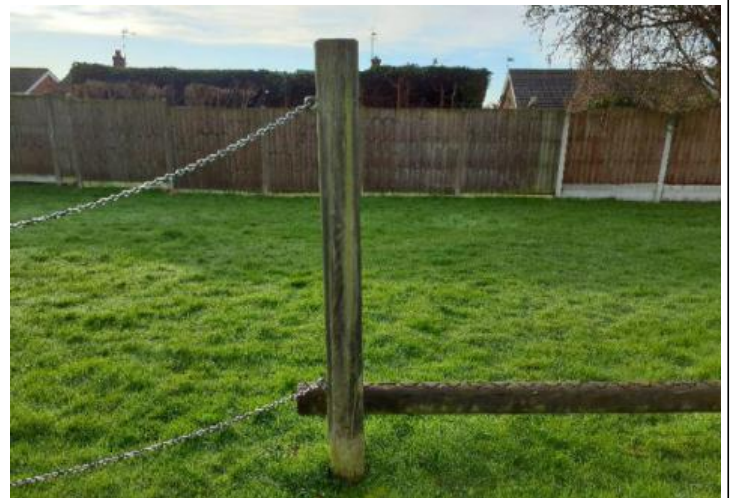
**Item:** Activity Equipment - Activity Trail  
**Manufacturer:** Playdale Playgrounds Ltd

**Finding:** The posts are leaning

**Action:** Reset as required

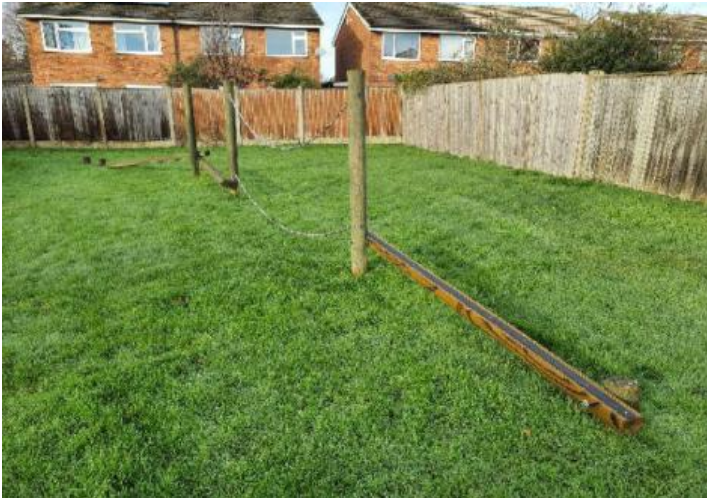
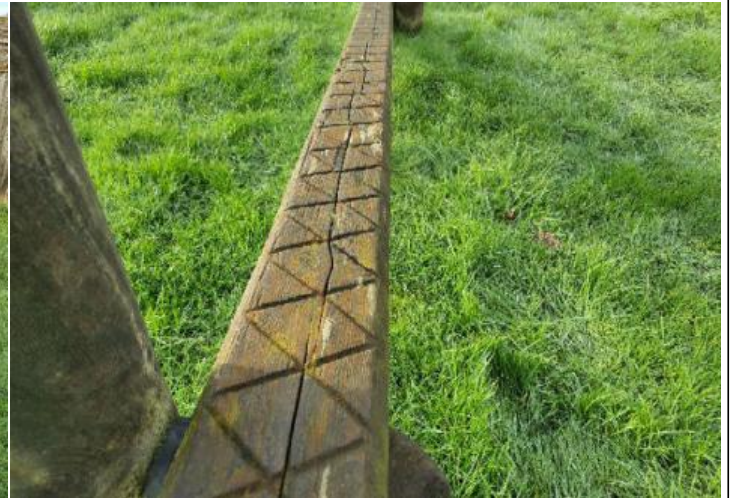
**Item:** Activity Equipment - Activity Trail  
**Manufacturer:** Playdale Playgrounds Ltd

**Finding:** The timber has a number of splits/shakes or air cracks and this may affect the stability or allow water ingress which will accelerate the rotting process. Timber splits may also create rough / splintering edges.

**Action:** Monitor, sand down any rough edges and ensure the splits do not cross through fixing points of the structure and/or cause any instability

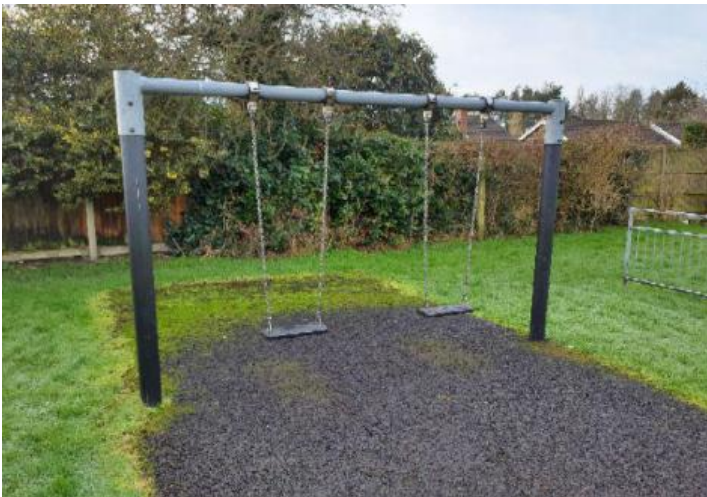
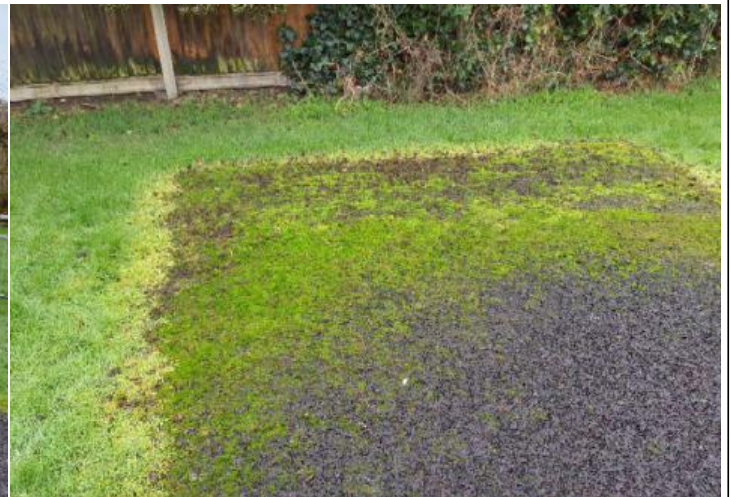
**Item:** Swings - 1 Bay 2 Seat (Flat)  
**Manufacturer:** Playdale Playgrounds Ltd

**Finding:** There is algae, silt or moss growth on the surface resulting in slippery conditions

**Action:** Clean and treat appropriately

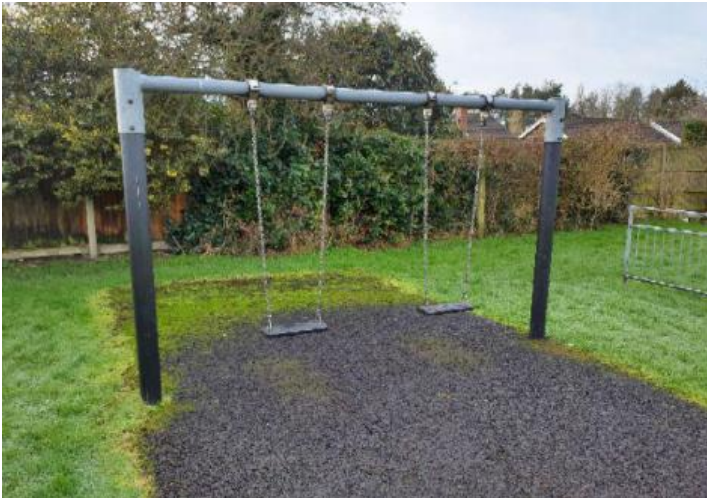
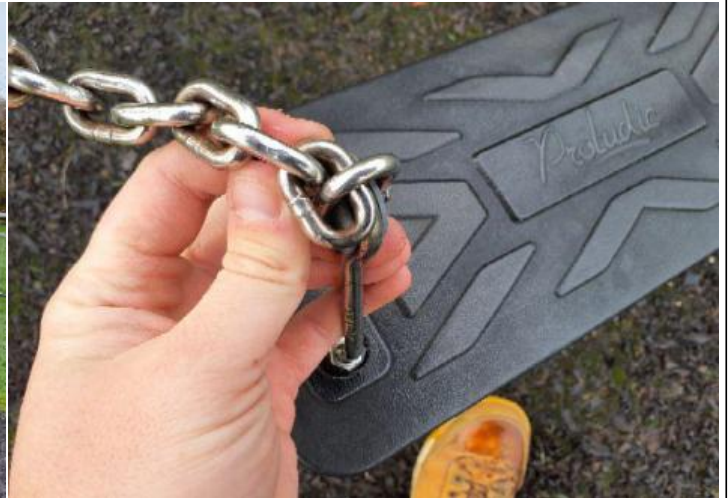
**Item:** Swings - 1 Bay 2 Seat (Flat)  
**Manufacturer:** Playdale Playgrounds Ltd

**Finding:** There is some notable evidence of chain wear

**Action:** Monitor for any further deterioration and replace when 40% worn

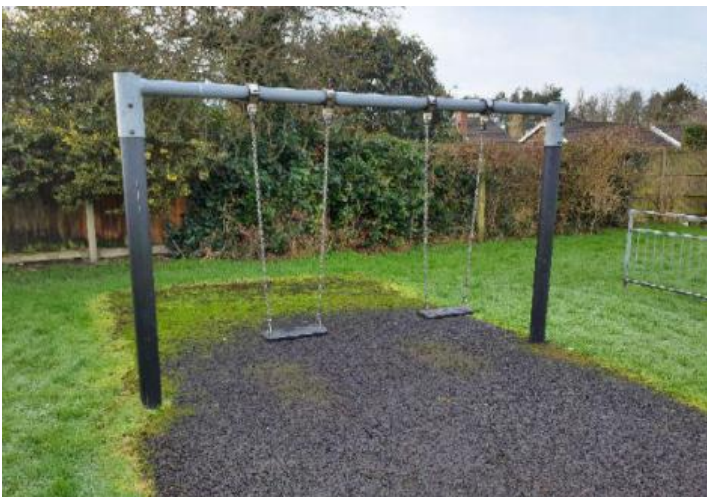
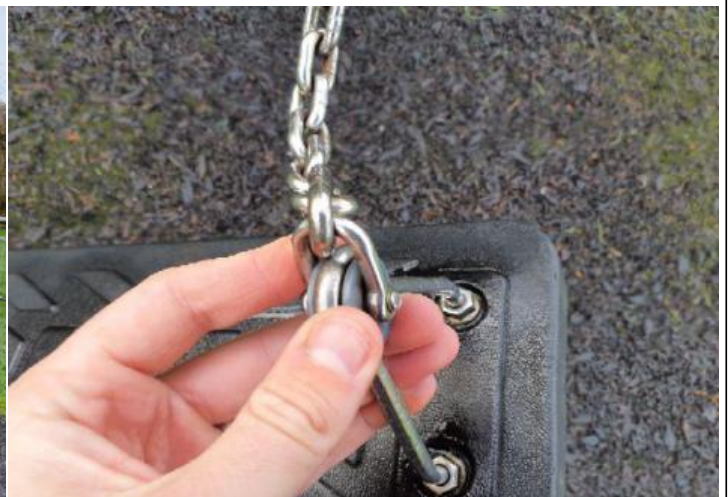
**Item:** Swings - 1 Bay 2 Seat (Flat)  
**Manufacturer:** Playdale Playgrounds Ltd

**Finding:** There is some wear to the shackles

**Action:** Monitor for any further deterioration and replace when 40% worn

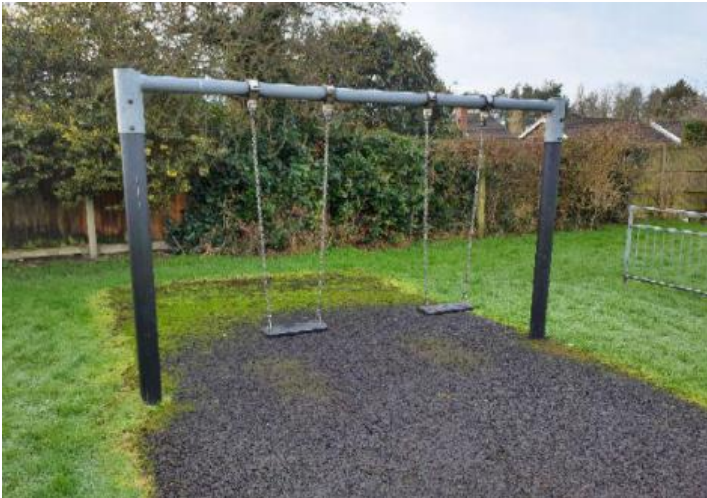
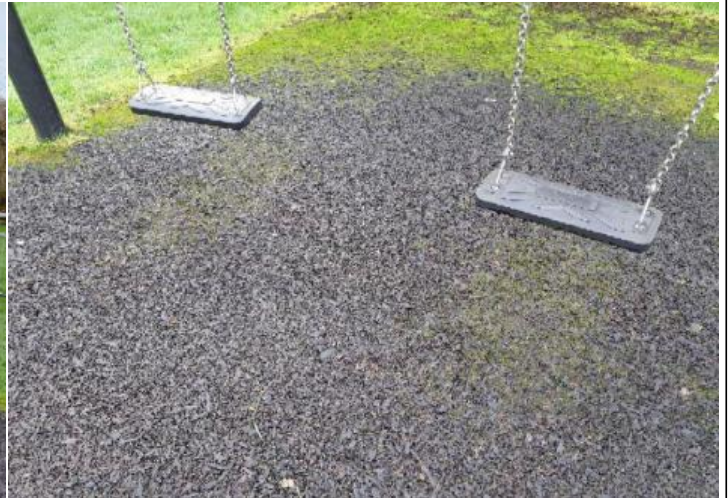
**Item:** Swings - 1 Bay 2 Seat (Flat)  
**Manufacturer:** Playdale Playgrounds Ltd

**Finding:** The safety surface around the area is beginning to wear

**Action:** Monitor for any further deterioration and repair as required

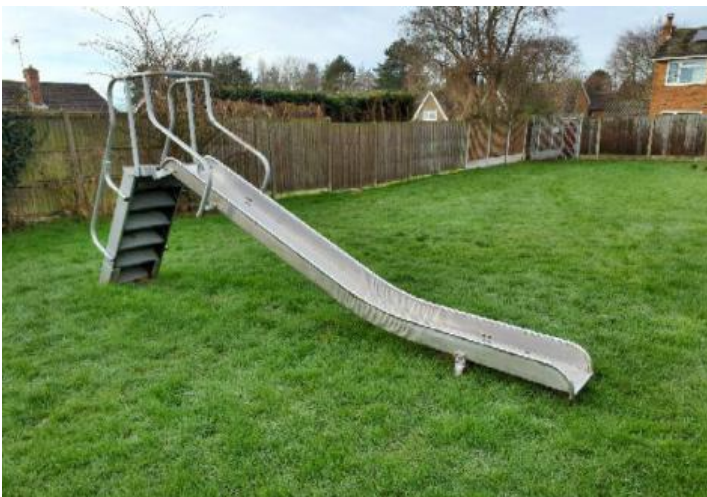
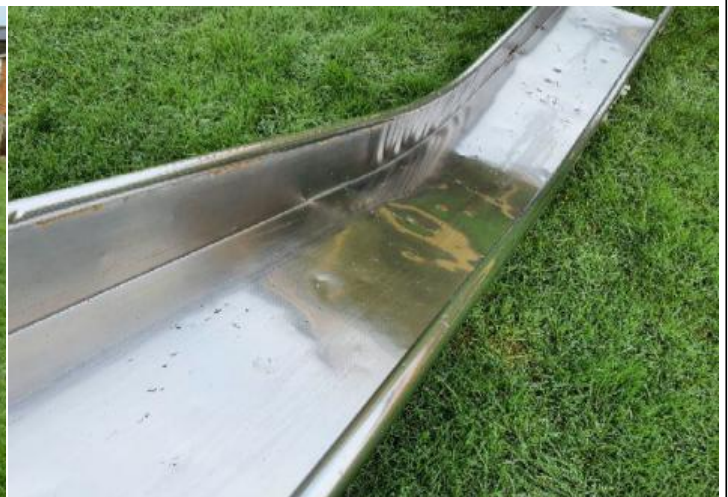
**Item:** Other - Free Standing Slide  
**Manufacturer:** Not Identified

**Finding:** There are a number of dents in the slide surface

**Action:** Monitor for any further deterioration and repair as required

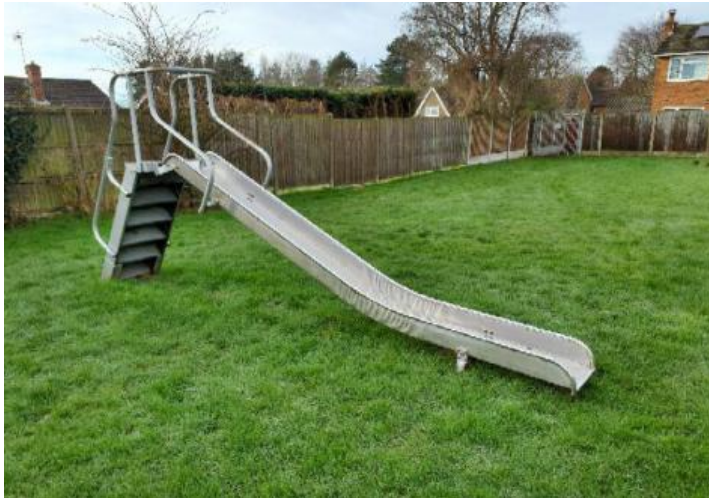
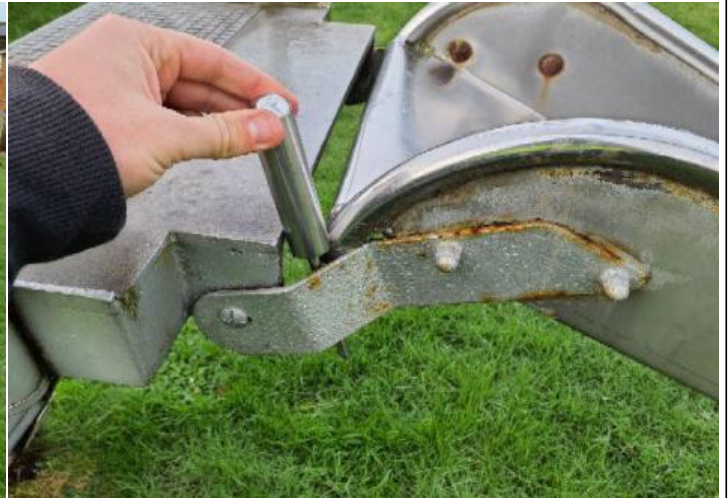
**Finding:** There is/are finger entrapment/s in the slide starting section and the item fails to meet the requirements of BS EN 1176 Part 1 4.2.7.6 Entrapment of fingers

**Action:** Remove entrapment

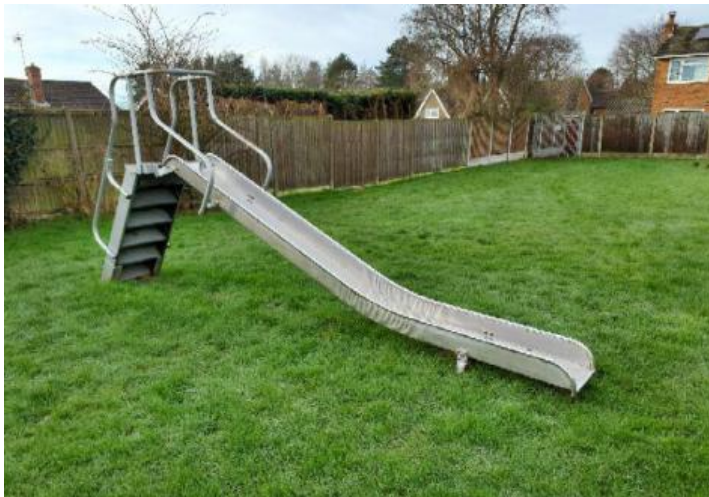
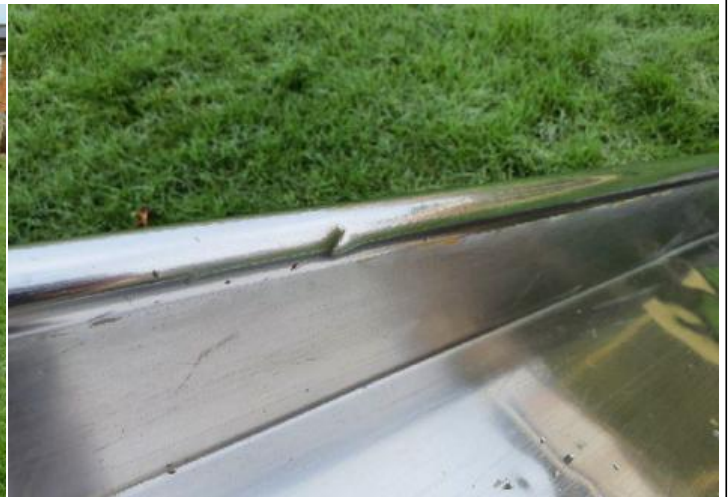
**Finding:** The side of the slide is damaged

**Action:** Monitor for any further deterioration and repair as required

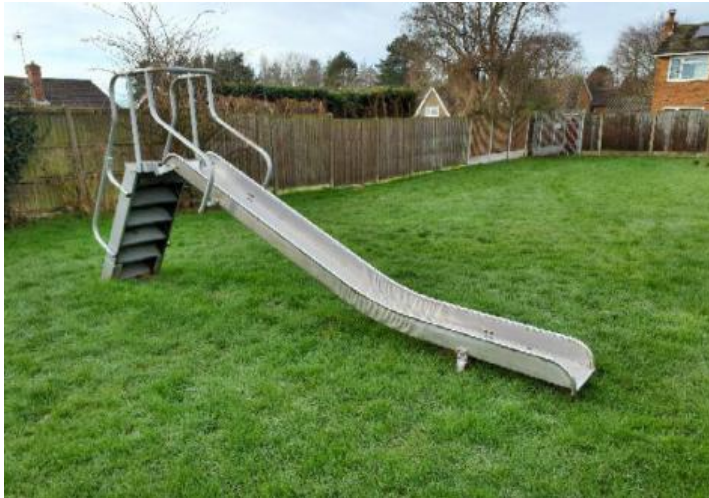
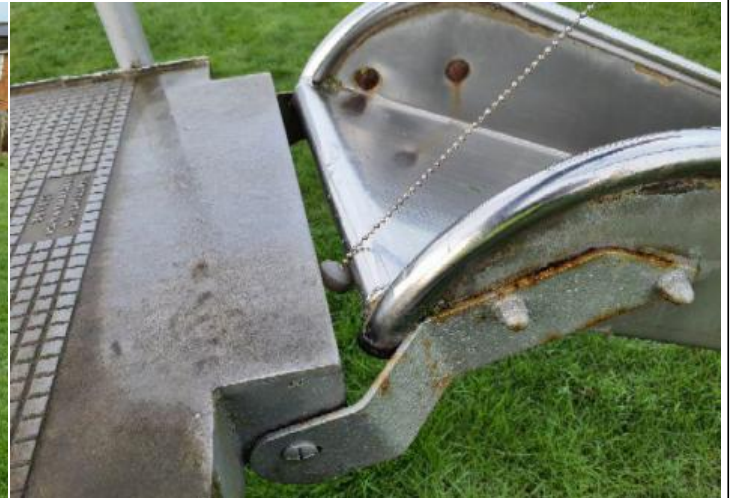
**Finding:** There is / are toggle entrapment/s present in contravention of the recommendations set out in BS EN 1176 Part 1

**Action:** Monitor - No action given the risk assessment

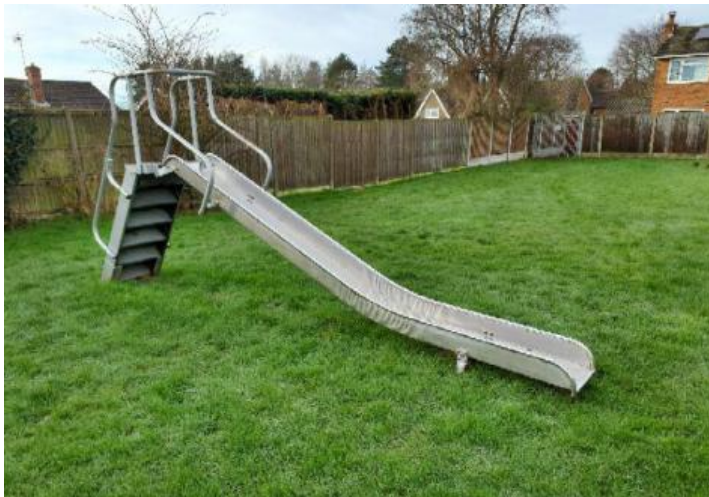
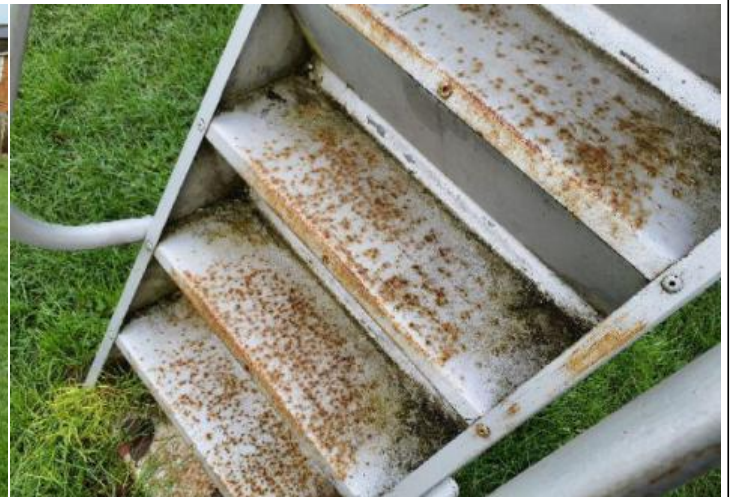
**Finding:** There is surface corrosion / rust present on the item

**Action:** Consider treating the item

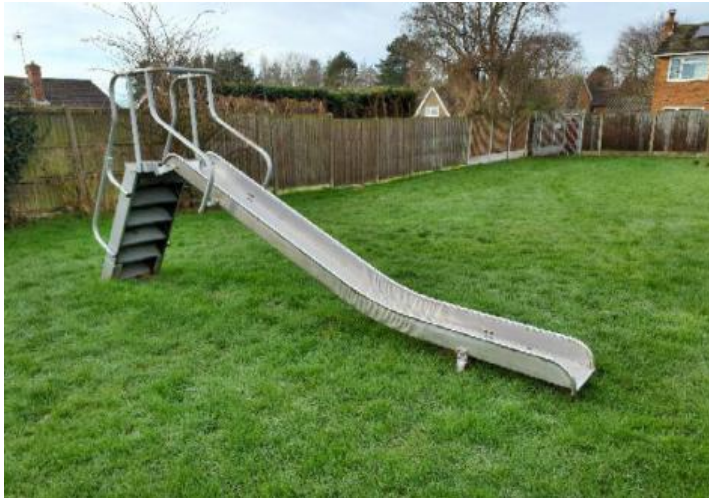
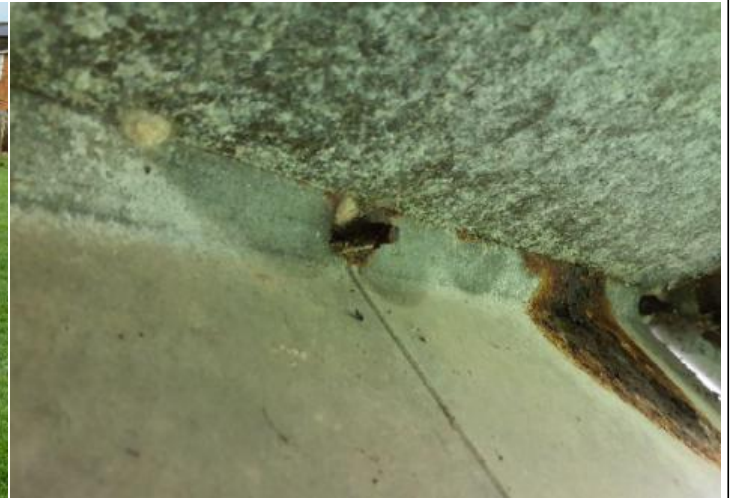
**Finding:** There are projecting bolt thread(s) present

**Action:** Remove excess thread length and deburr or provide cap
